Problem with the surface reference sample

Test the surface reference sample in order to check if it had any damage

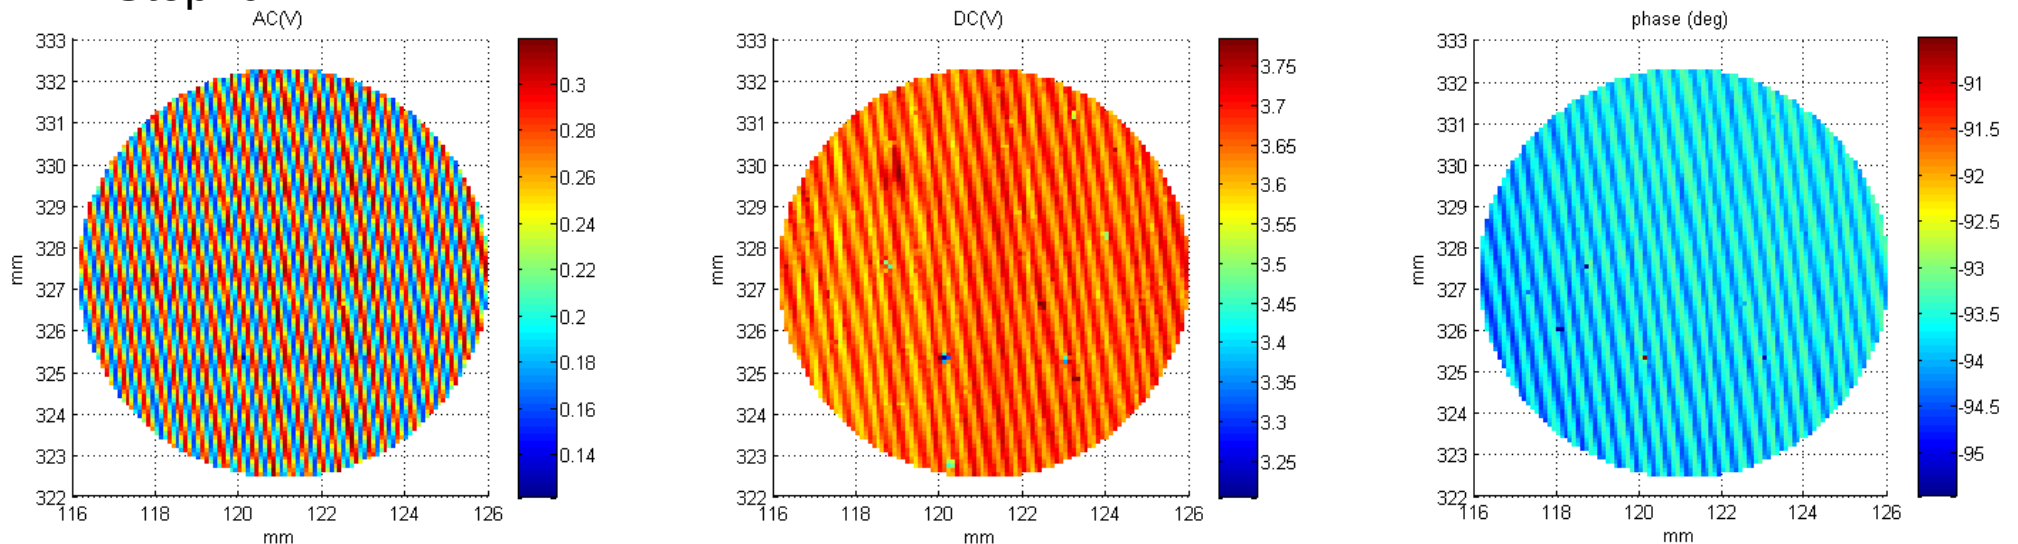
Diameter: 10 mm
Step: 0.1mm

- AC signal (expected to be proportional to the absorption), has periodic oscillations by a factor of ~ 2
- DC and phase are pretty constant but follow the same pattern
- Looks like real absorption
- Looks like the sample is damaged and absorption is not uniform

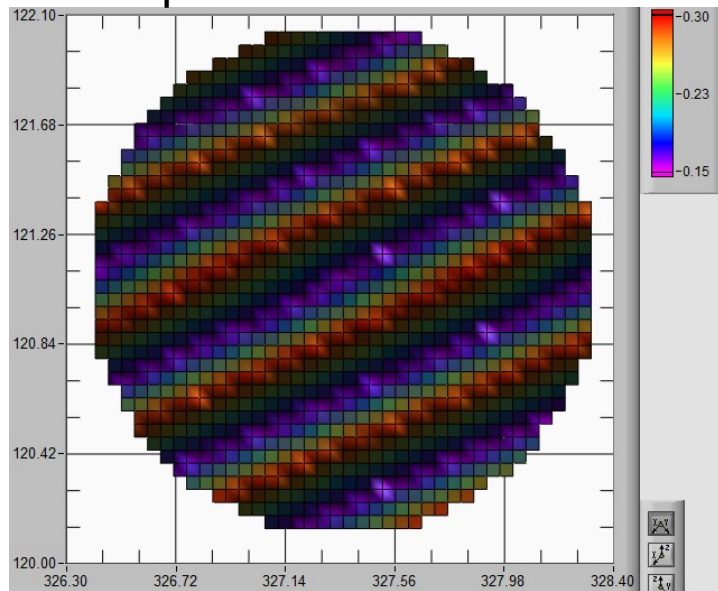
Diameter: 2mm
Step: 0.05mm

Made a smaller and more resolved map around the center
Then rotated the sample by 90° and the pattern rotates.

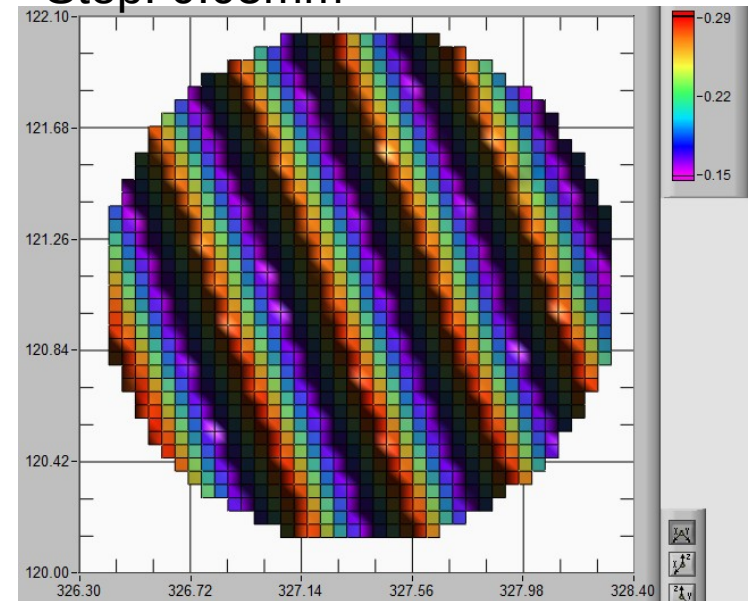
Diameter: 2mm
Step: 0.05mm

Rotated by 90°

- Looks like the problem is in the sample

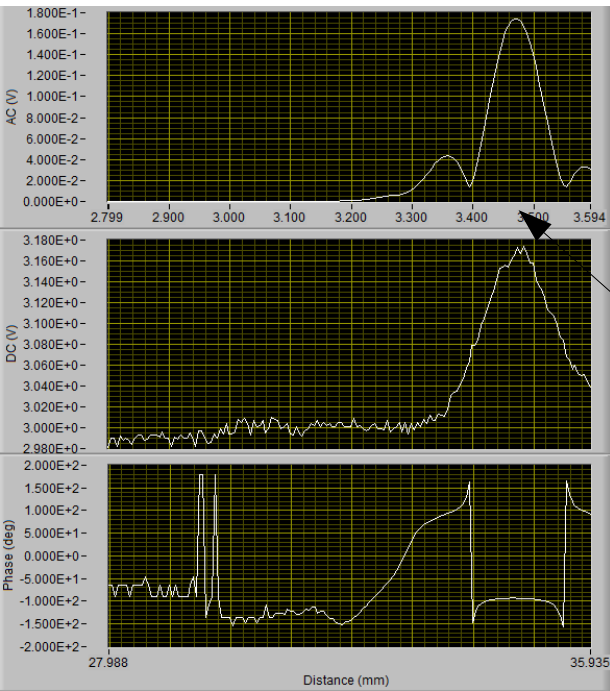
Z=34.7mm

- Flipped the sample and made a new scan

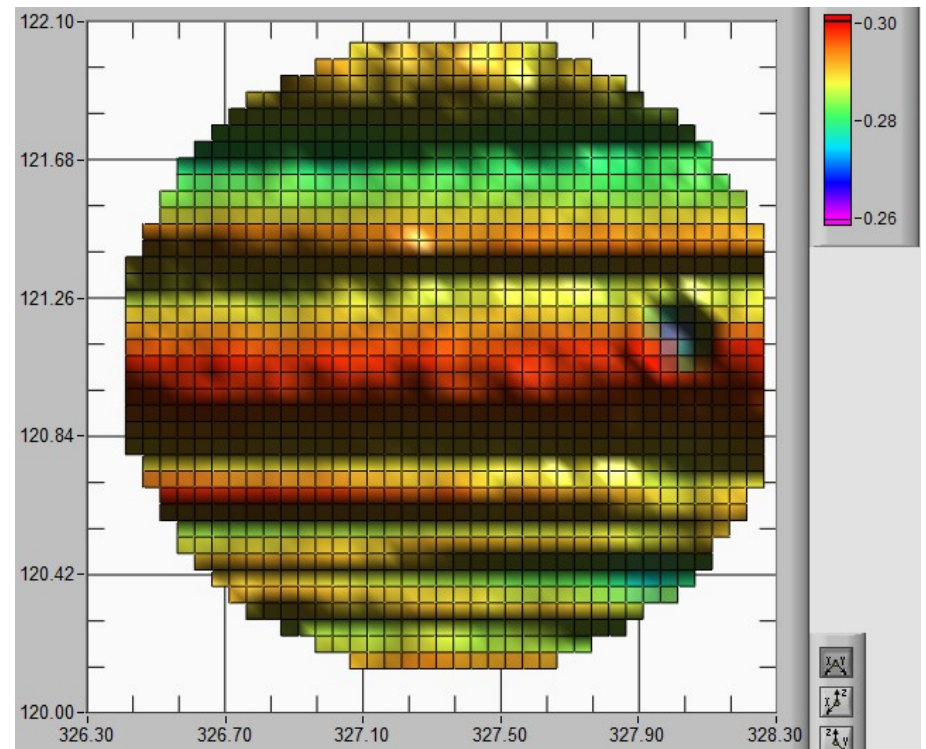
- Moved the sample to the new maximum position and made a map

The pattern is a bit different and with lower amplitude

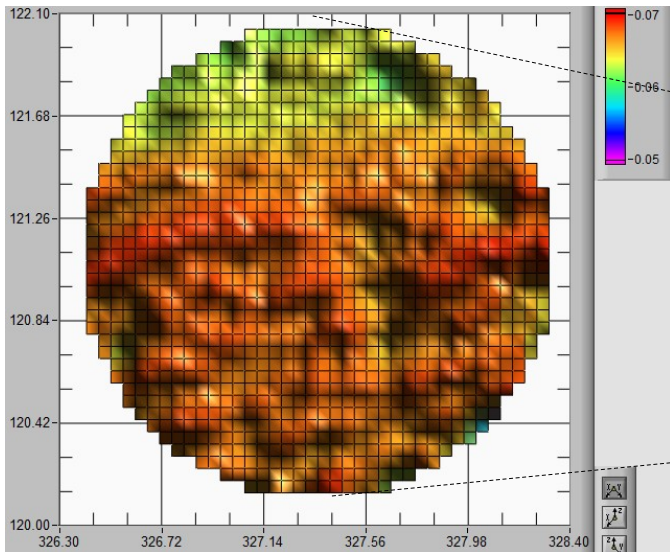
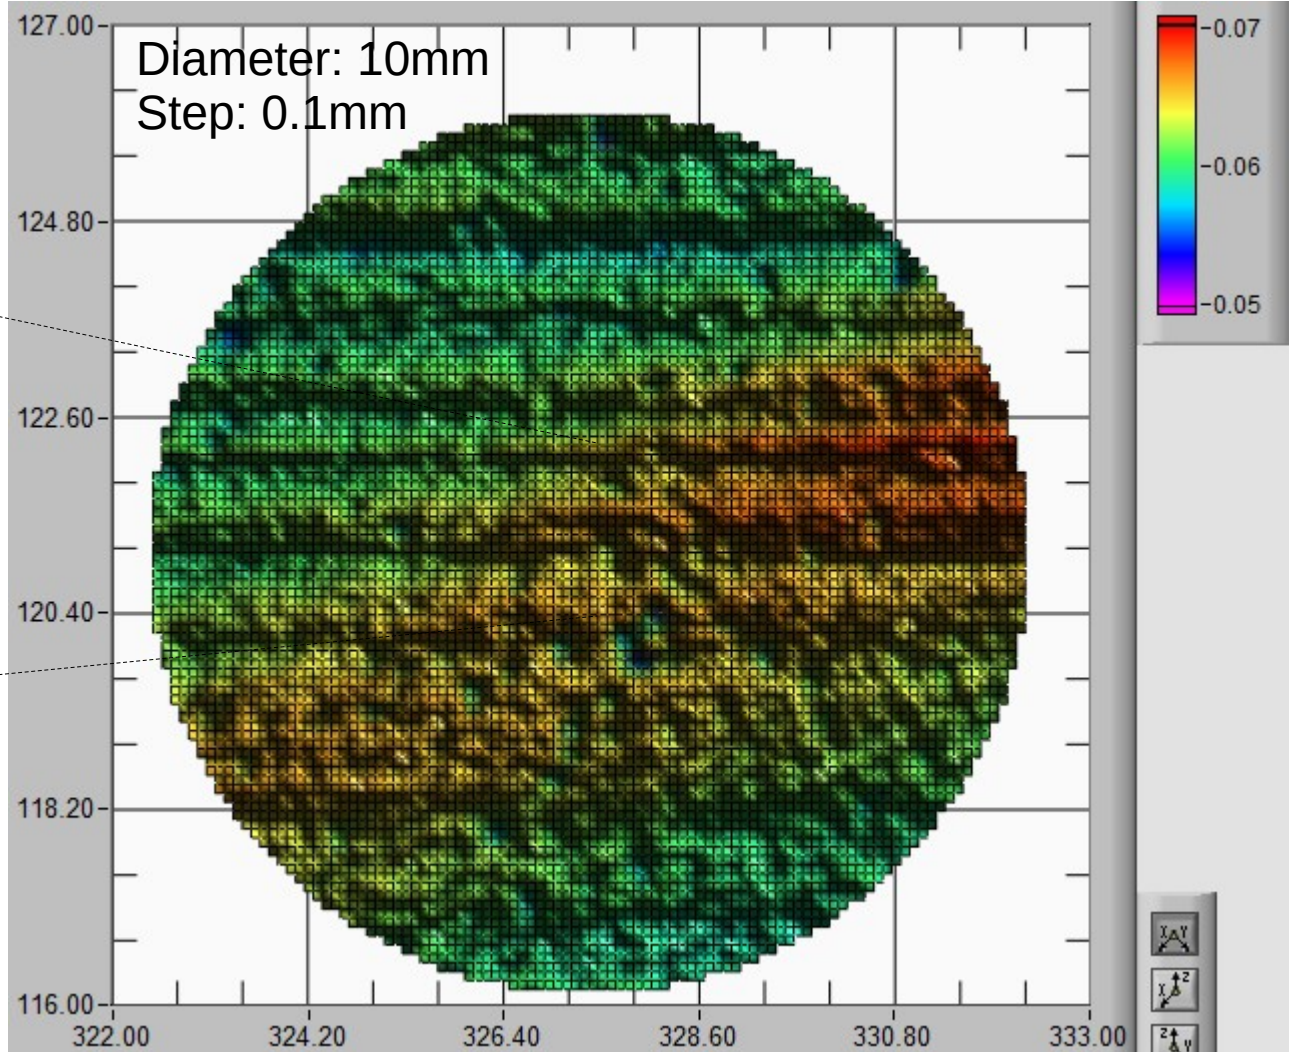
Diameter: 2mm
Step: 0.05mm

THE PATTERN DOESN'T SHOW IN THE BULK REFERENCE SAMPLE

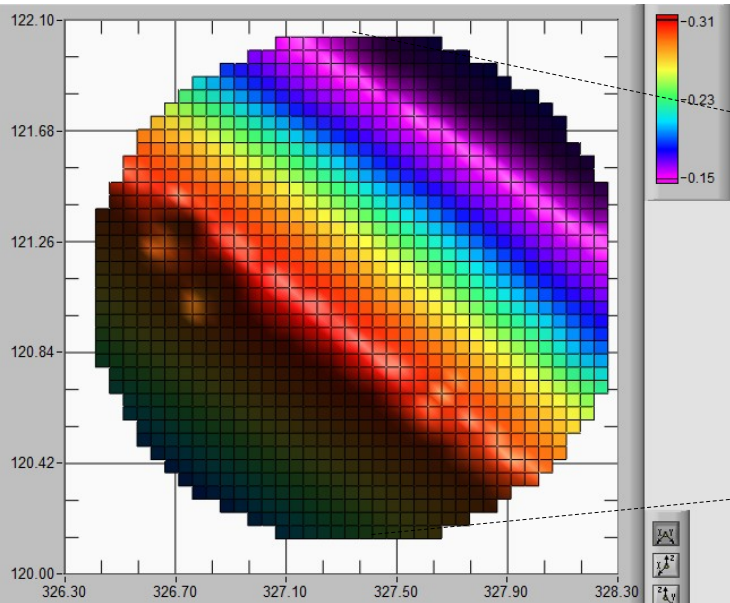
Diameter: 2mm
Step: 0.05mm

Also the new sample shows a similar pattern but with larger fringes separation:

- **New sample: 5 fringes/cm**
- **Old sampe: 25 fringes/cm**

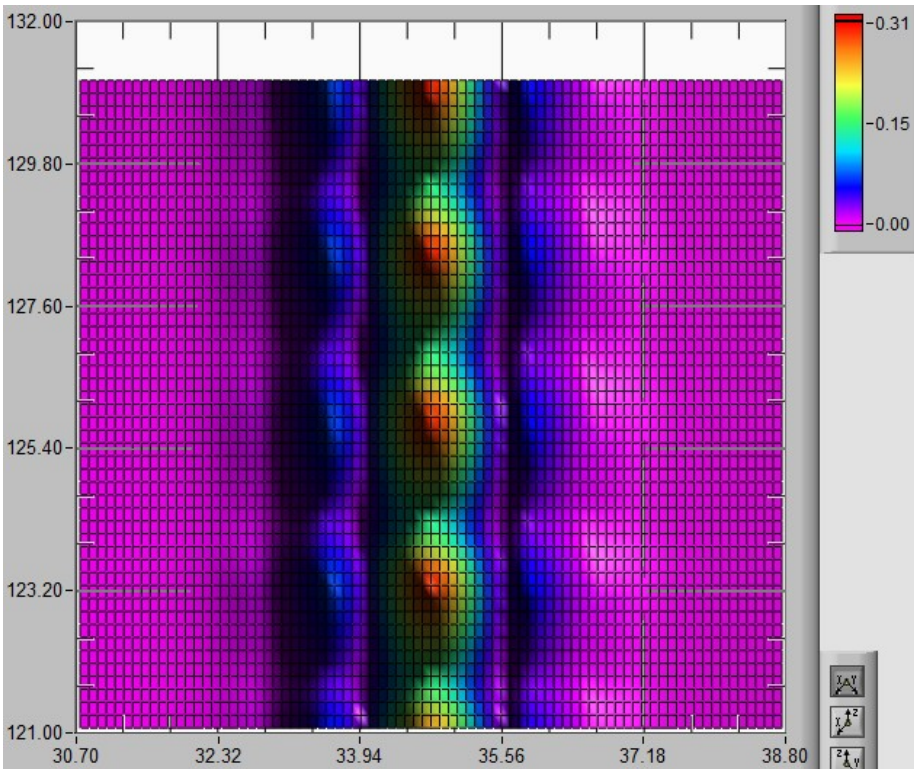
Map along Y and Z axis

This map shows the cross section of the coating with the absorption fringes (like many scans along Z for different Y positions)

- The damage reason is excluded by the fact that we can see a similar pattern on the new sample.
- Another possible reason is the wedge of the sample, which is different for different samples, in combination with a misalignment. Although the specs say: wedge < 3 arc min
- I will try to make a better alignment of the crossing point and see if something changes
