# Checking of Optical Chopper: SR540

April 1st, 2016  
Daisuke Tatsumi

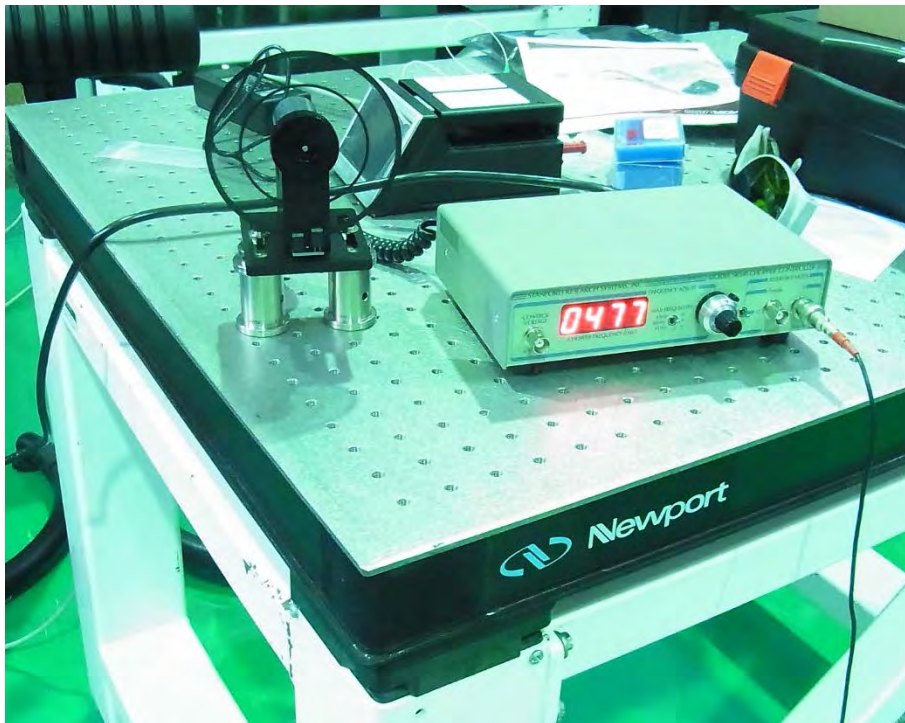
Picture 1:  
Optical chopper  
Stanford Research Systems  
SR540

Manual claimed in his report that a replaced (new) optical chopper has some problems.

**[CONCLUSION]**  
**The chopper has no problems and works well.**

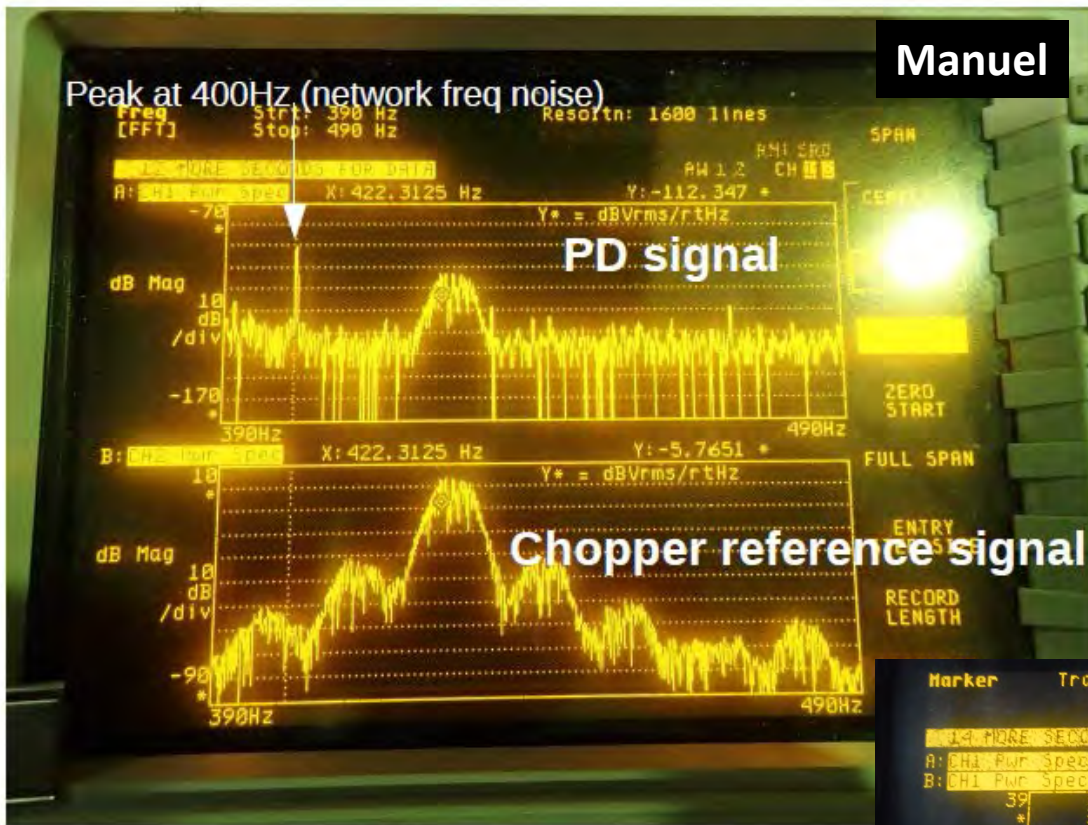
Picture 1:

Manuel

Peak at 400Hz (network freq noise)

From Manuel's report chopping frequency is not stable.

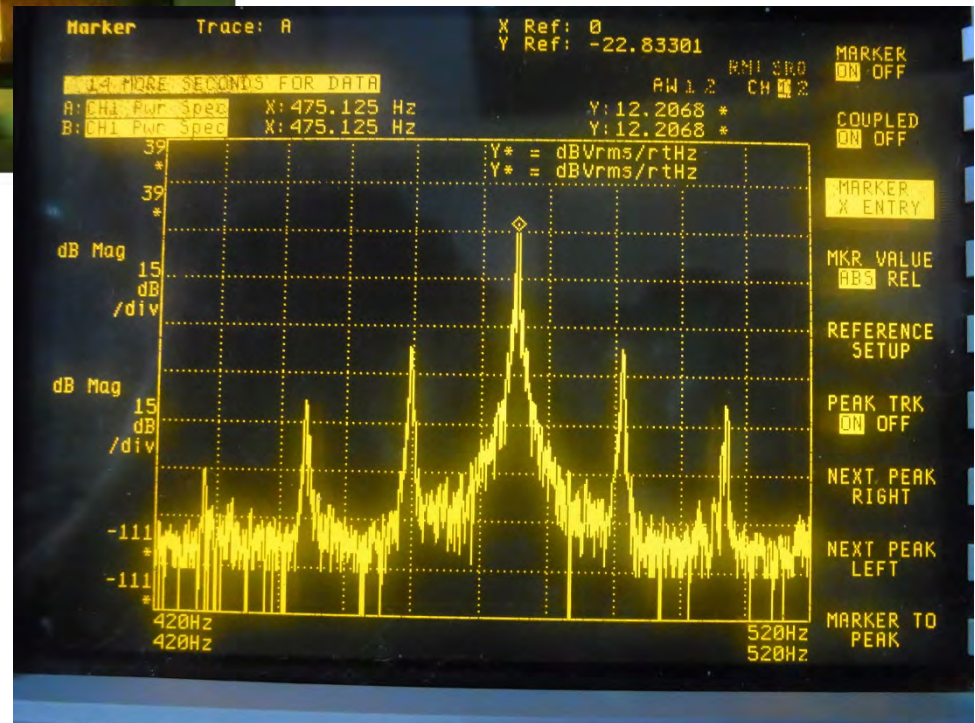
Picture 2:

Spectrum of chopper output signal.

This spectrum is different from Manuel's one obviously.

Both x-axis set same 100 Hz range.

Reasons are expected as follows;

a) I put the chopper on optical table directly.

b) One leg was not fixed tightly.

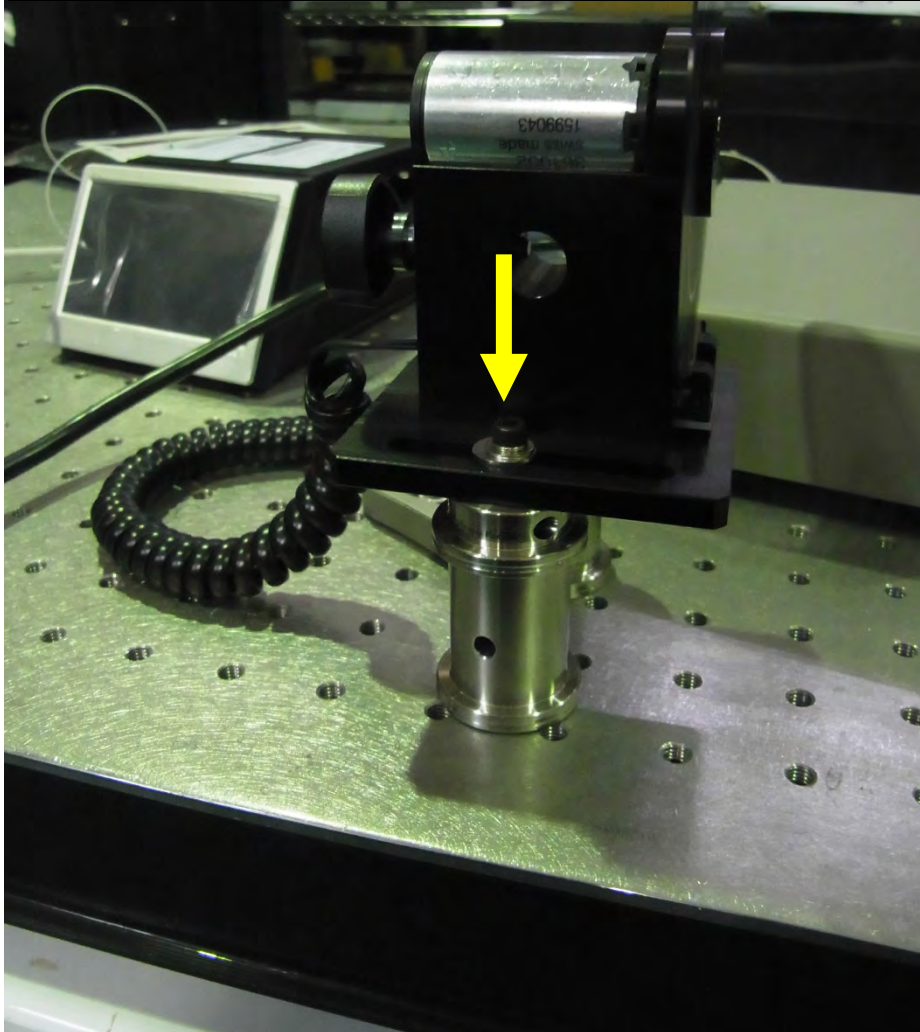
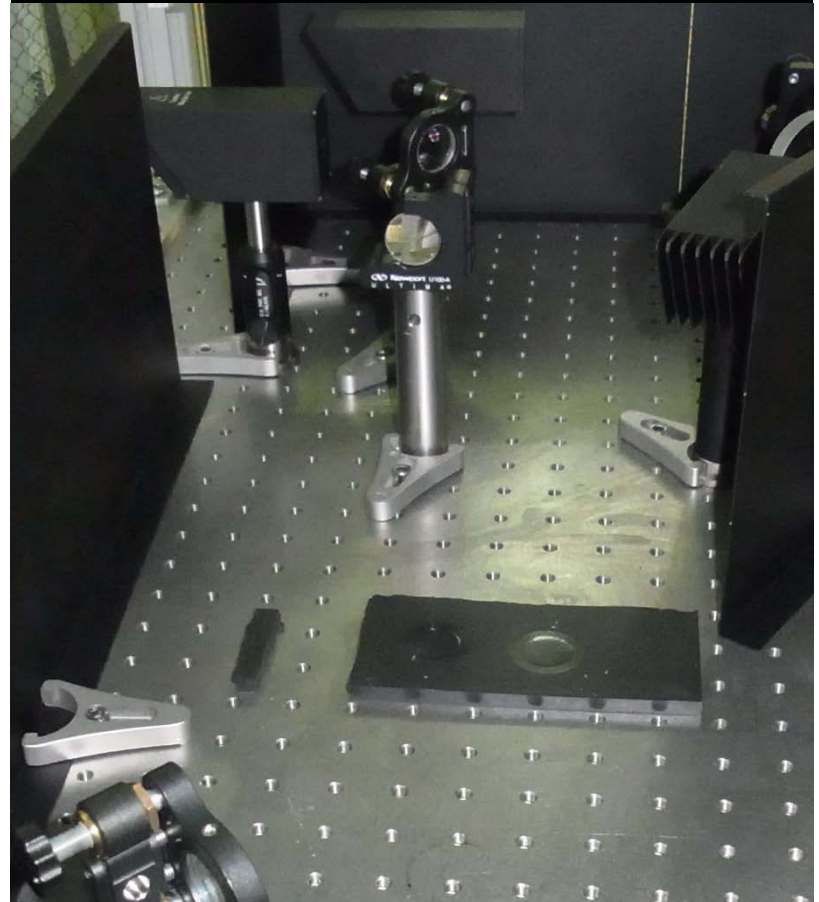
On absorption measurement bench the chopper put on the rubber sheet to reduce the environmental noises.

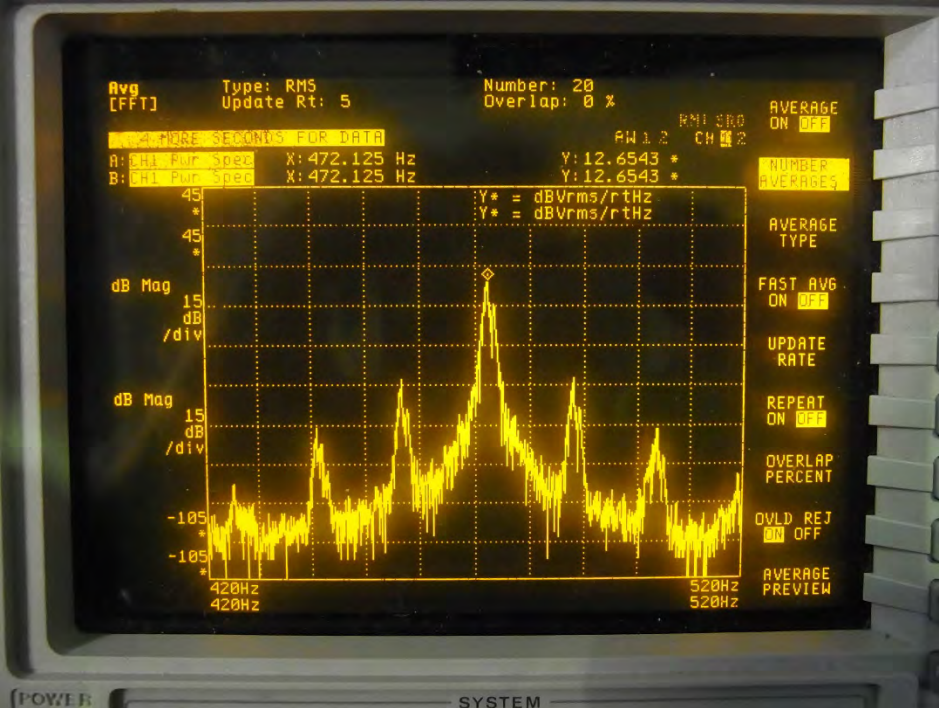
Spectrum of 16 seconds data

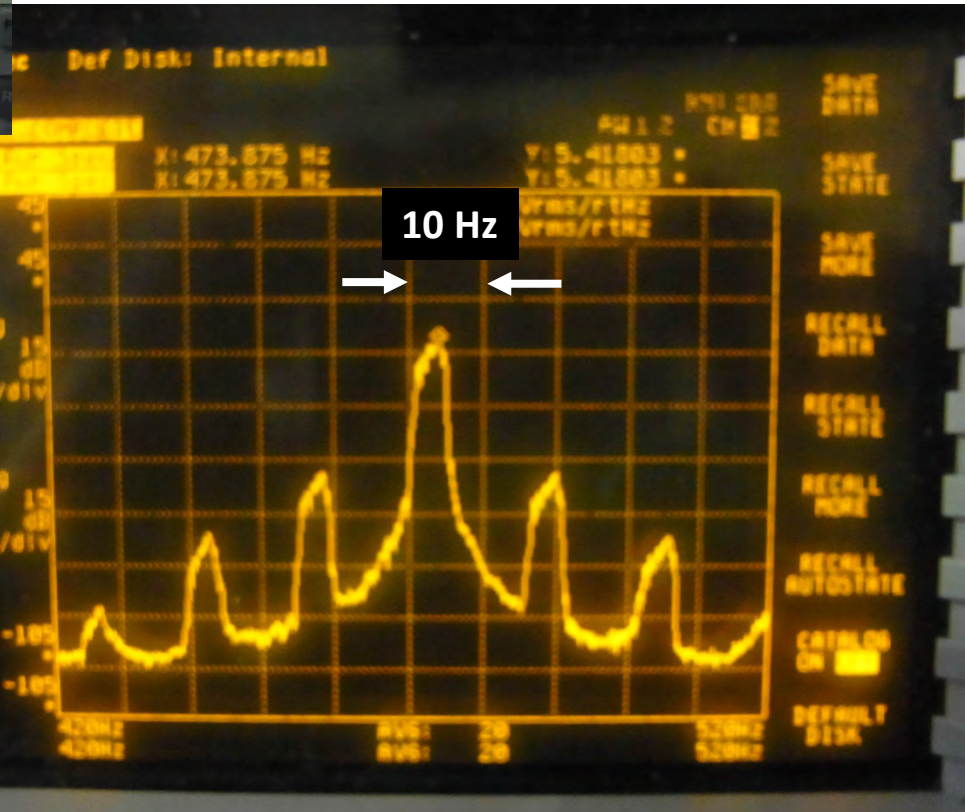
Spectrum of 16 seconds data with 20 times averaging. (320 sec in total)  
Shift of rotational frequency makes the peak wider.

Catalogue spec. for long-term drift is  $<2\%$ . Therefore, an expected drift is less than  $475 \text{ Hz} \times 2\% = 9.5 \text{ Hz}$ .  
This amount of drift is acceptable.
